**Biological Assessment and Essential Fish Habitat
Assessment for the Proa and TPU Cable Systems - Tinian
Branching Units**

Draft Biological Assessment and Essential Fish Habitat Assessment for Project Pika Subsea Cable System

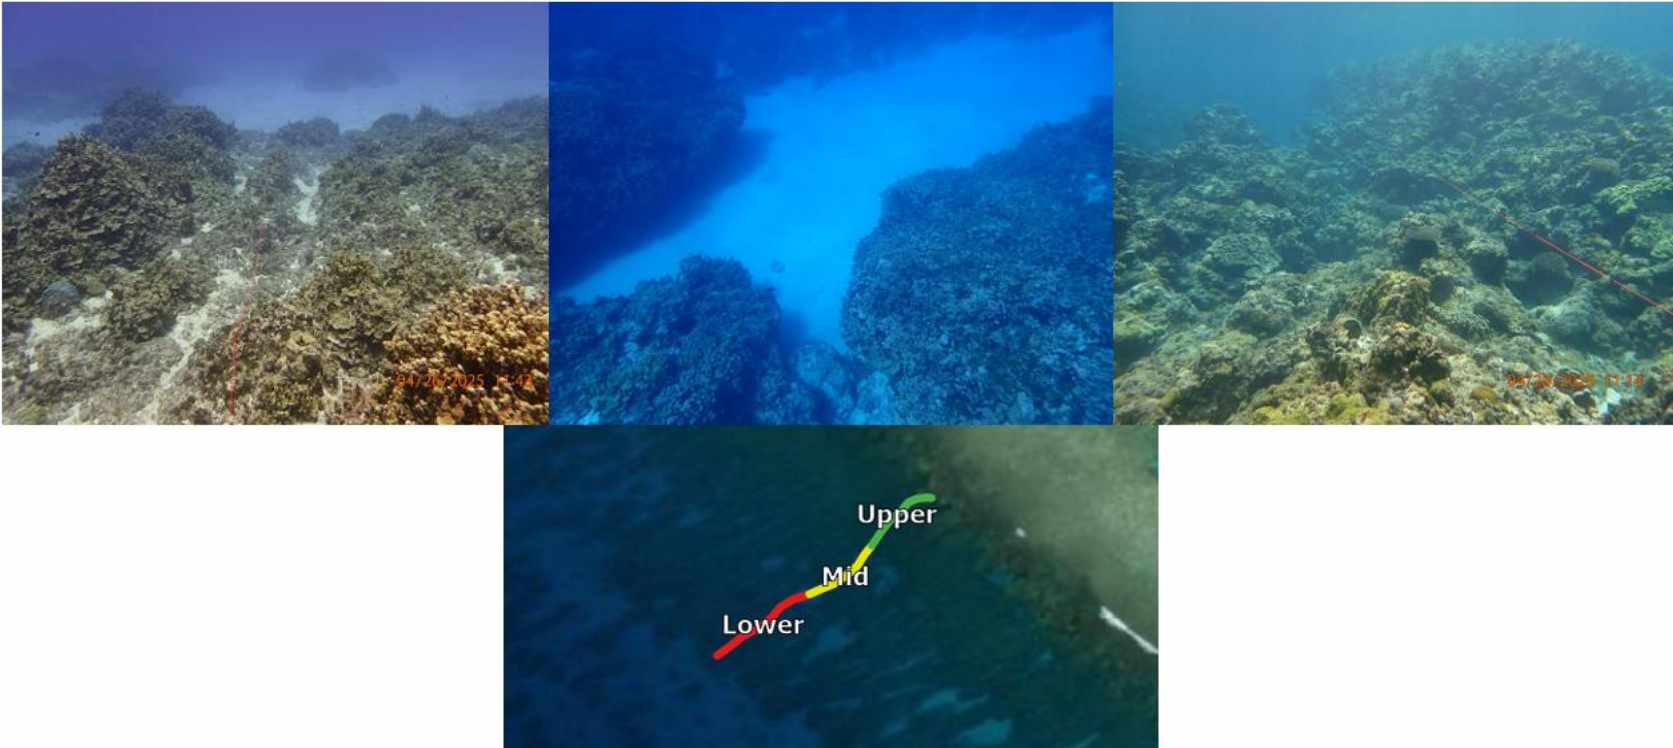
Figure 3: Designation of forereef zones for analysis of benthic substrate data.

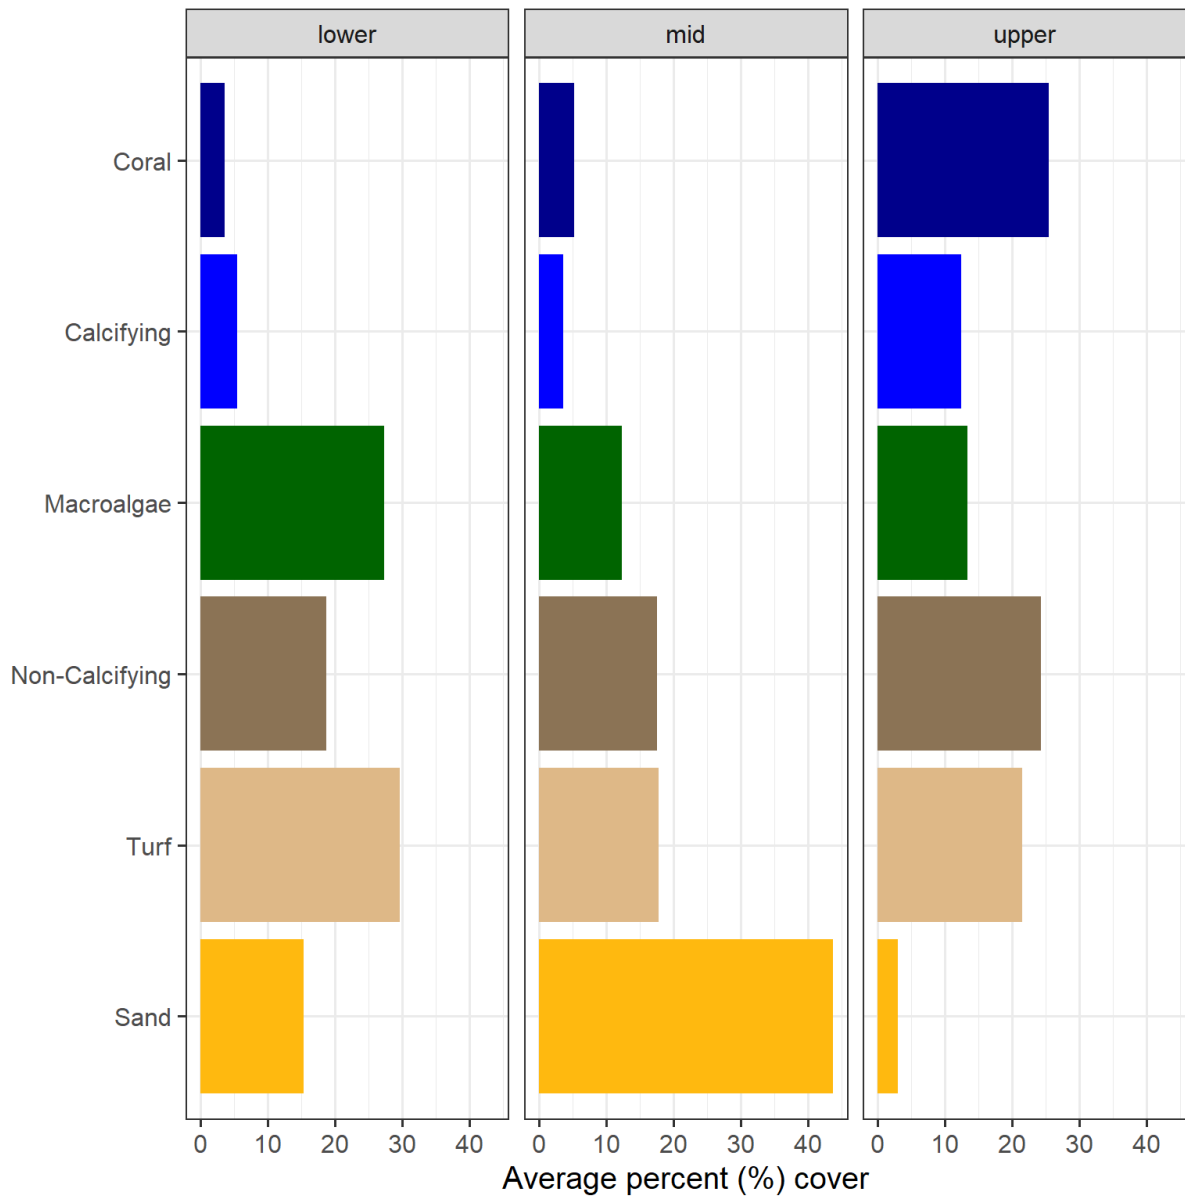
Figure 4: Percent Benthic Cover of the identified route for Task 1.

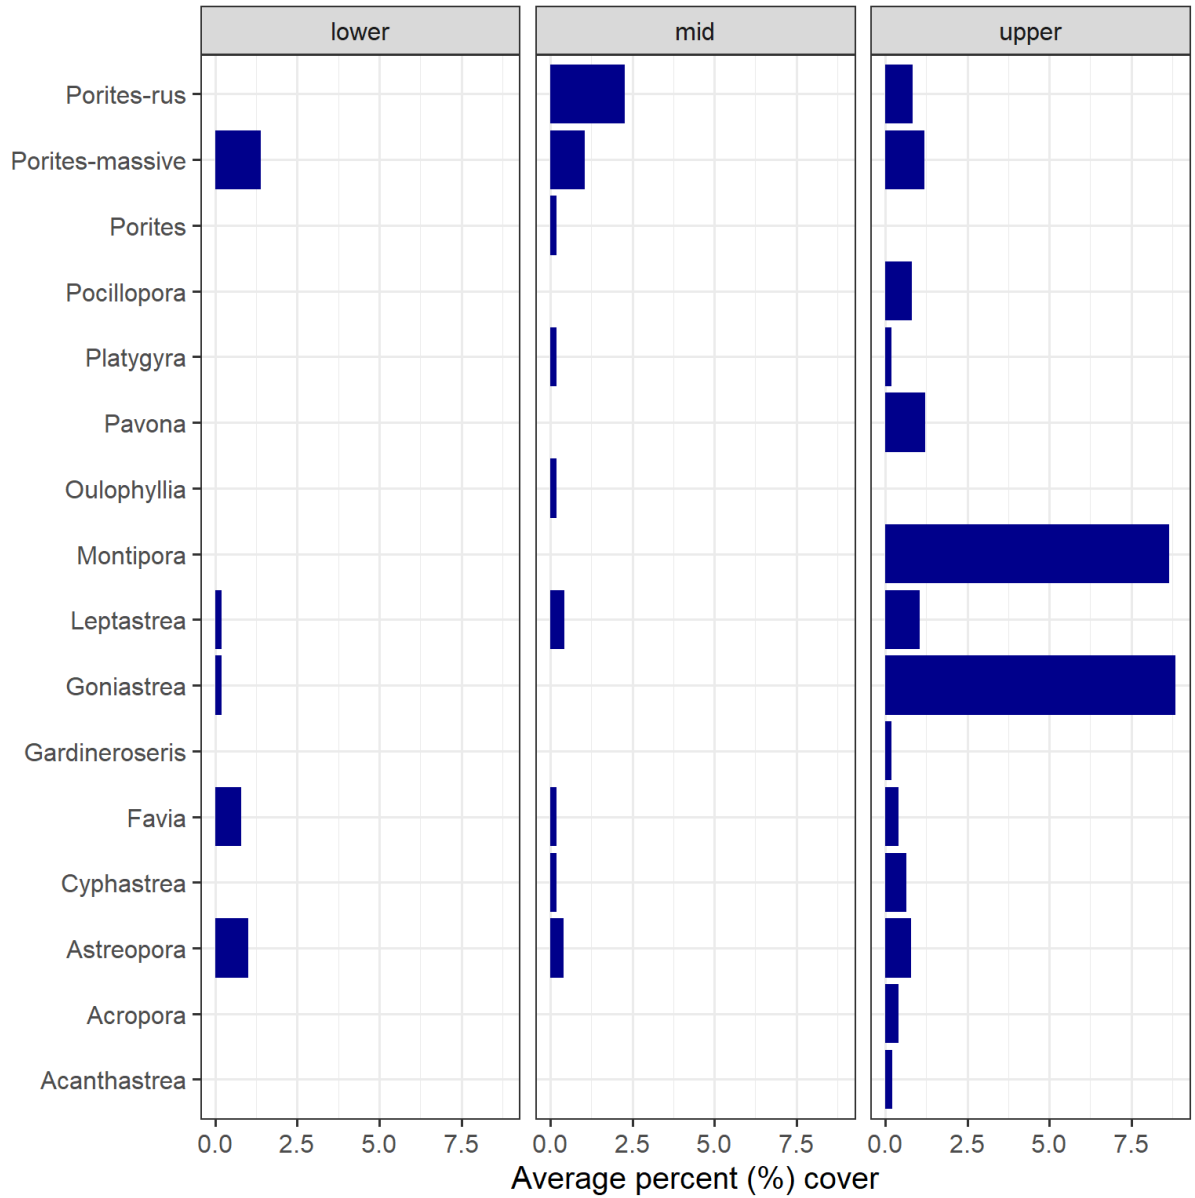
Figure 5: Percent Coral Cover by Genus of the identified route for Task 1.

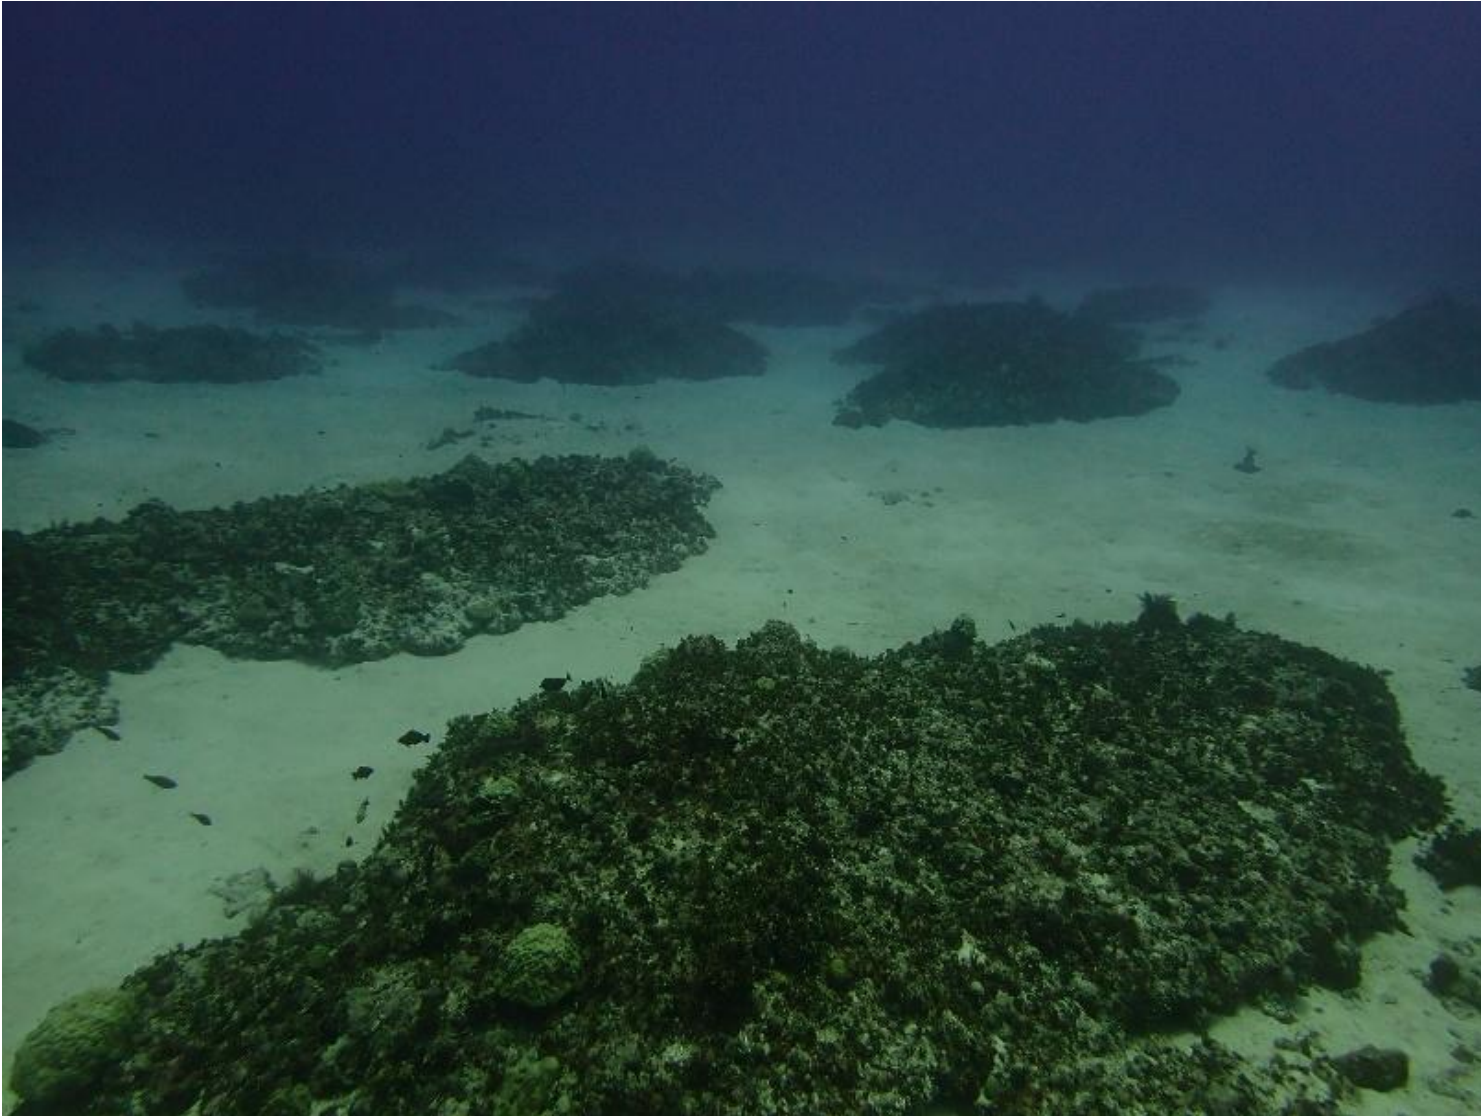
Figure 9: Coral patches on sandy bottom. Across all three routes, most of the individual colonies were observed on these patches.

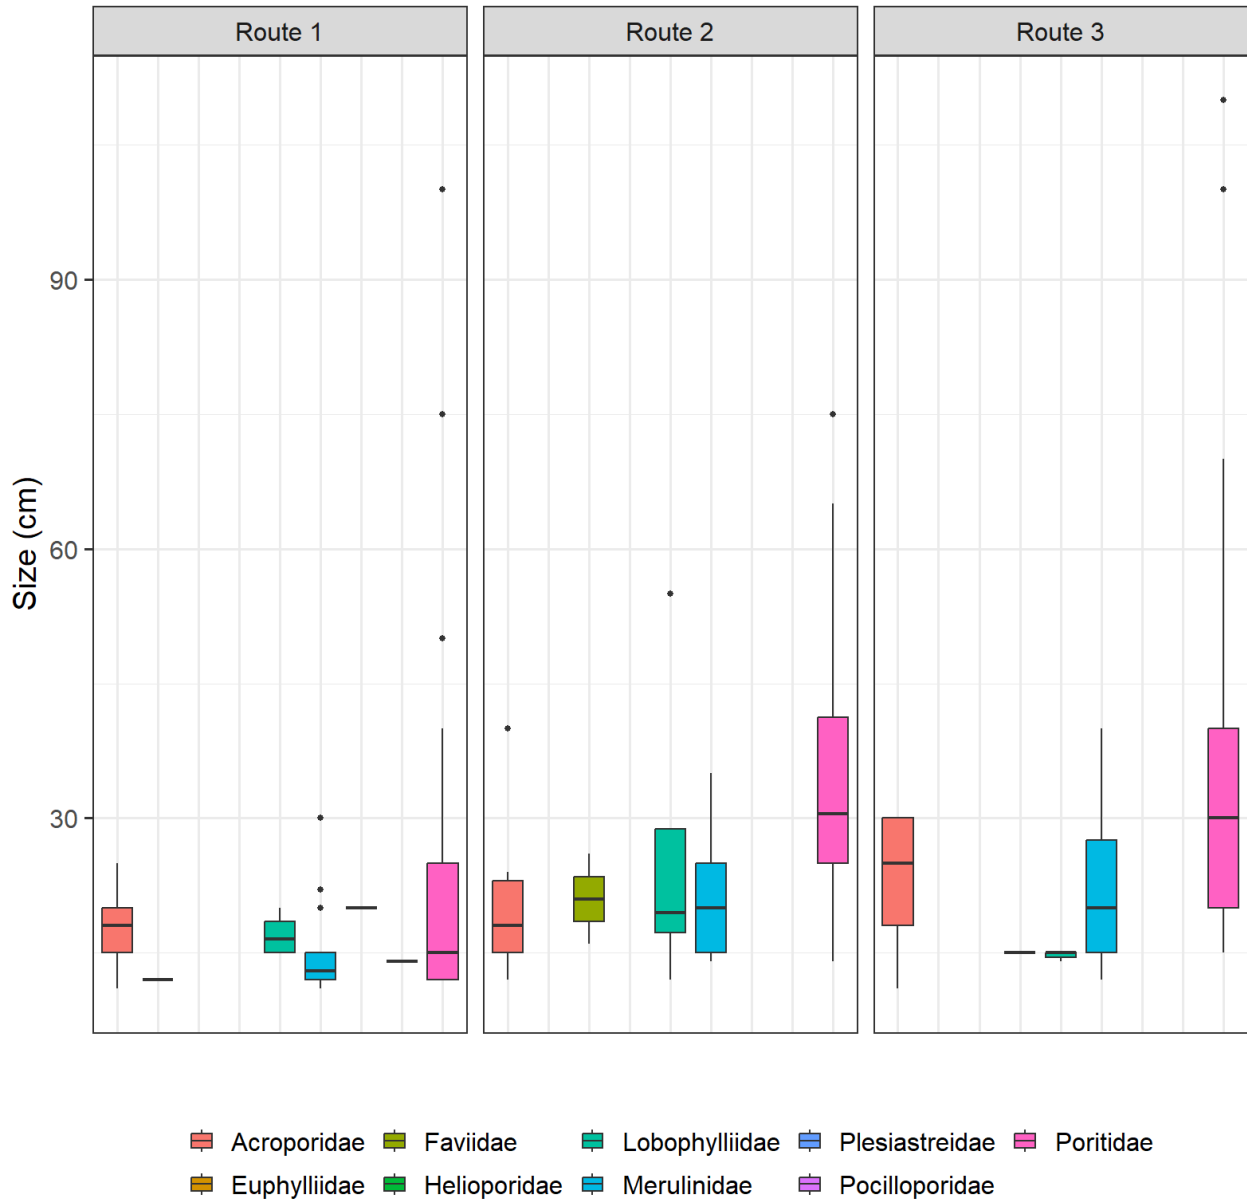
Figure 10: Coral distribution by size and abundance of families.

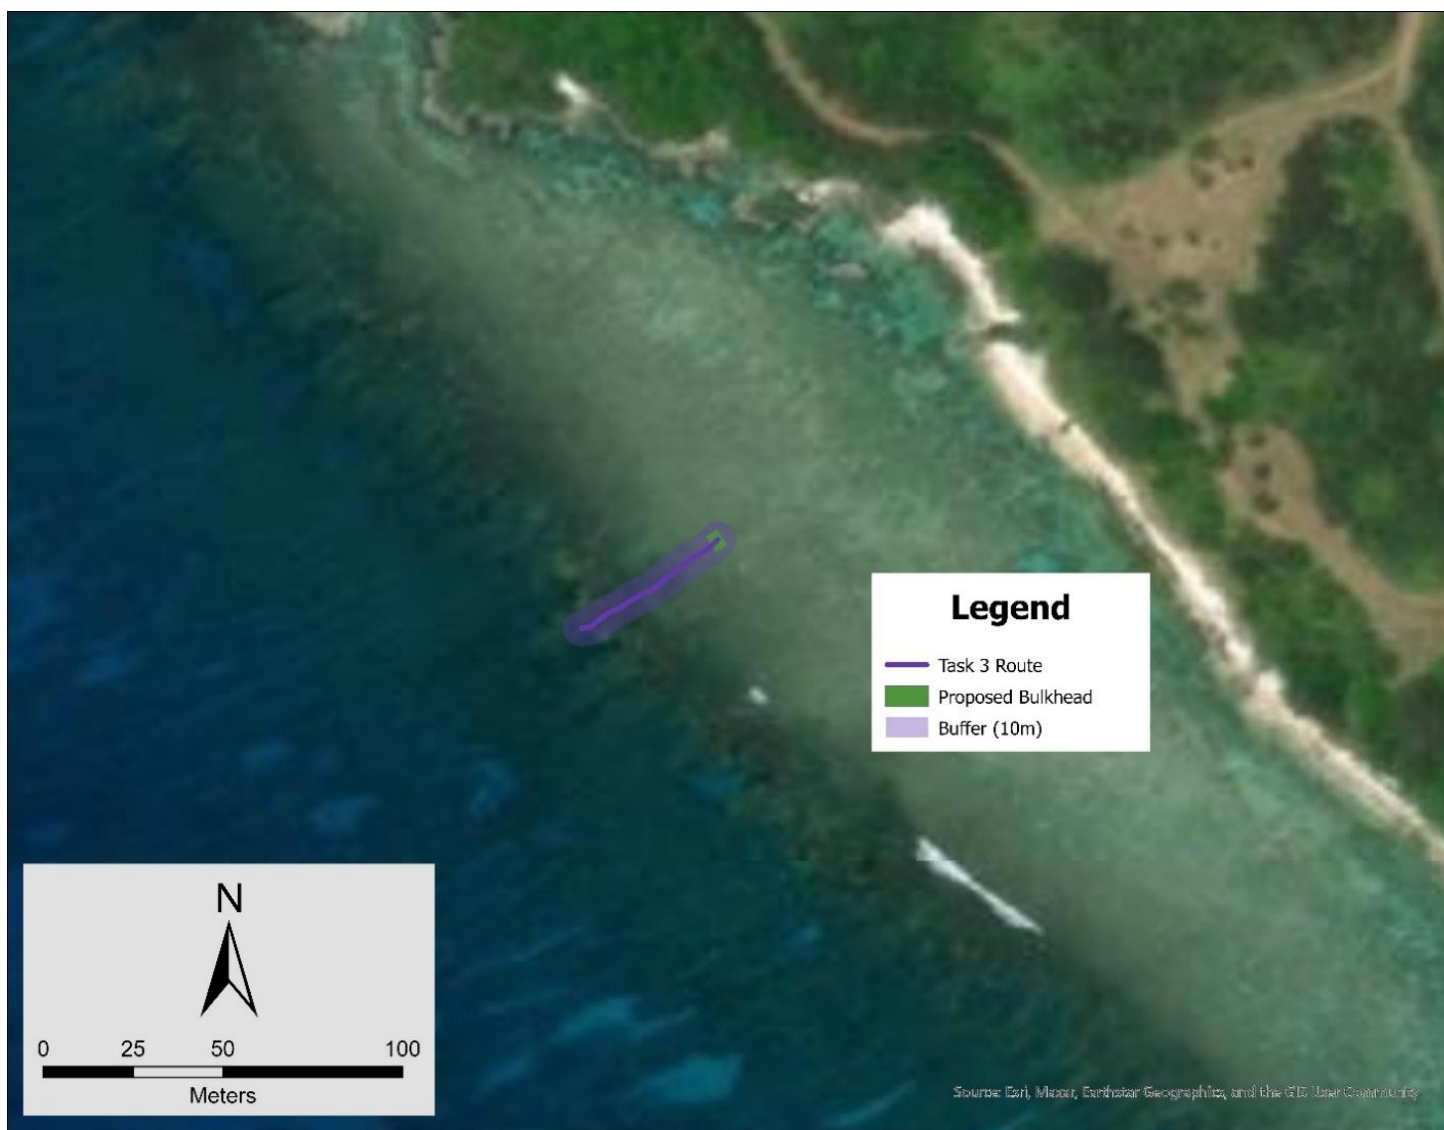
Figure 13: Map of Task 3 route from the reef crest extending onto the reef flat to the proposed bulkhead.

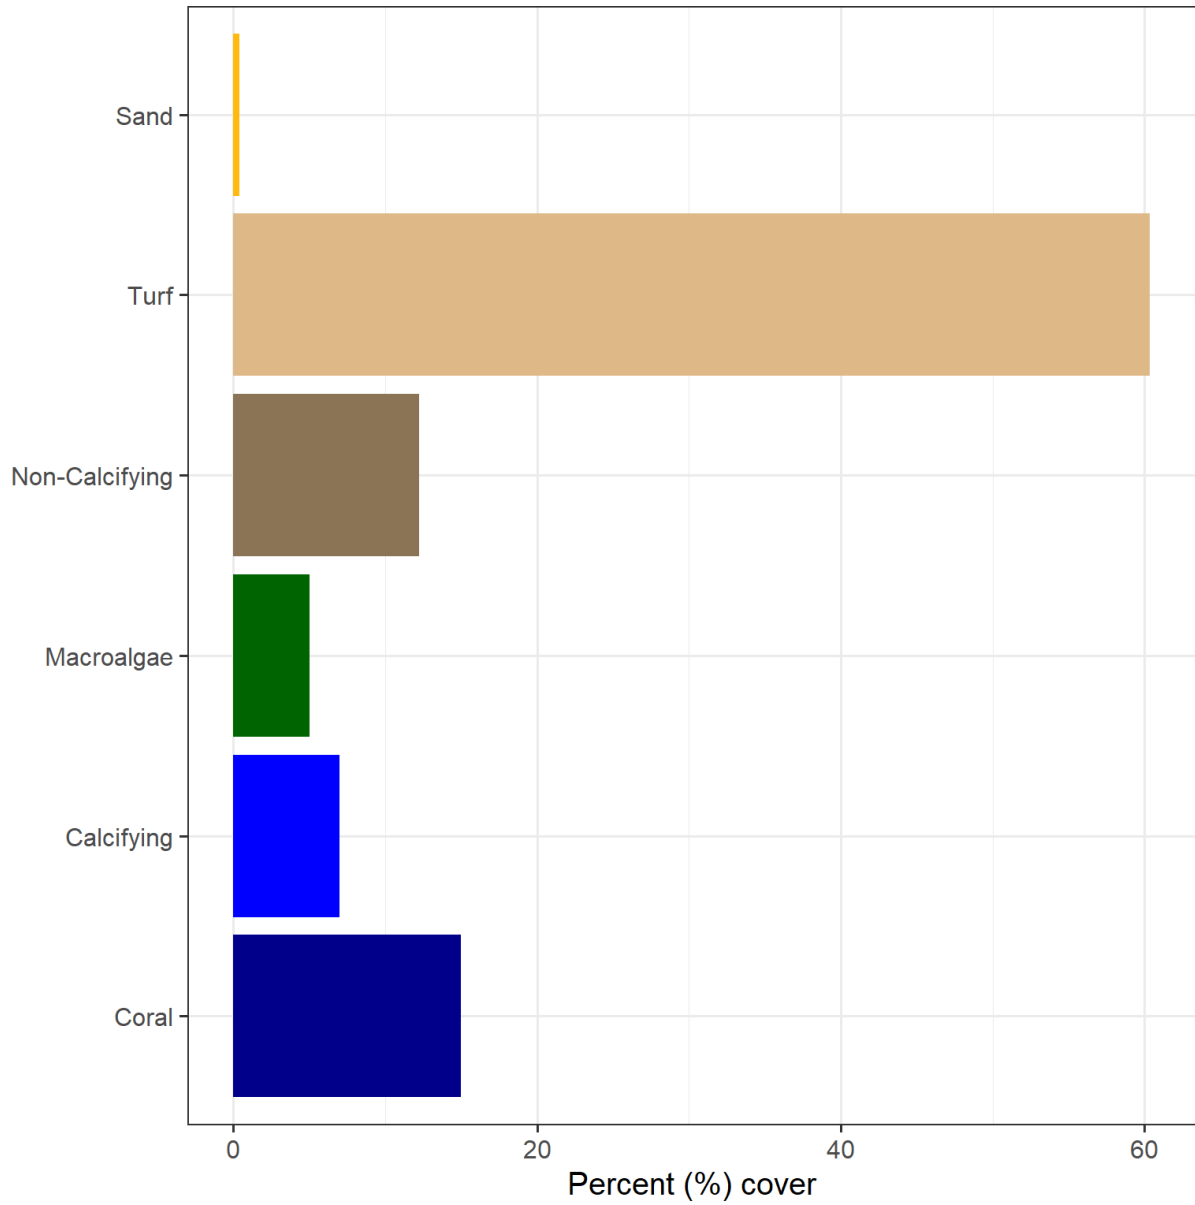
Figure 14: Percent benthic cover for cable landing corridor to the BHM (Task 3)

Potential long-term stressors include disturbance to reef structure and foraging habitat from marine bulkhead, cable, and articulated pipe installation across the reef. The April 2025 survey of the reef flat determined that it was a turf-dominated benthic habitat with moderate live coral presence and low sedimentation (Appendix A). Turf algae accounted for 60% of the total benthic cover with 15% coral, 14% non-calcifying substrates, and the remainder calcifying algae and macroalgae. Two green sea turtles were observed to be foraging in the nearshore reef habitat during the 2-day habitat surveys.

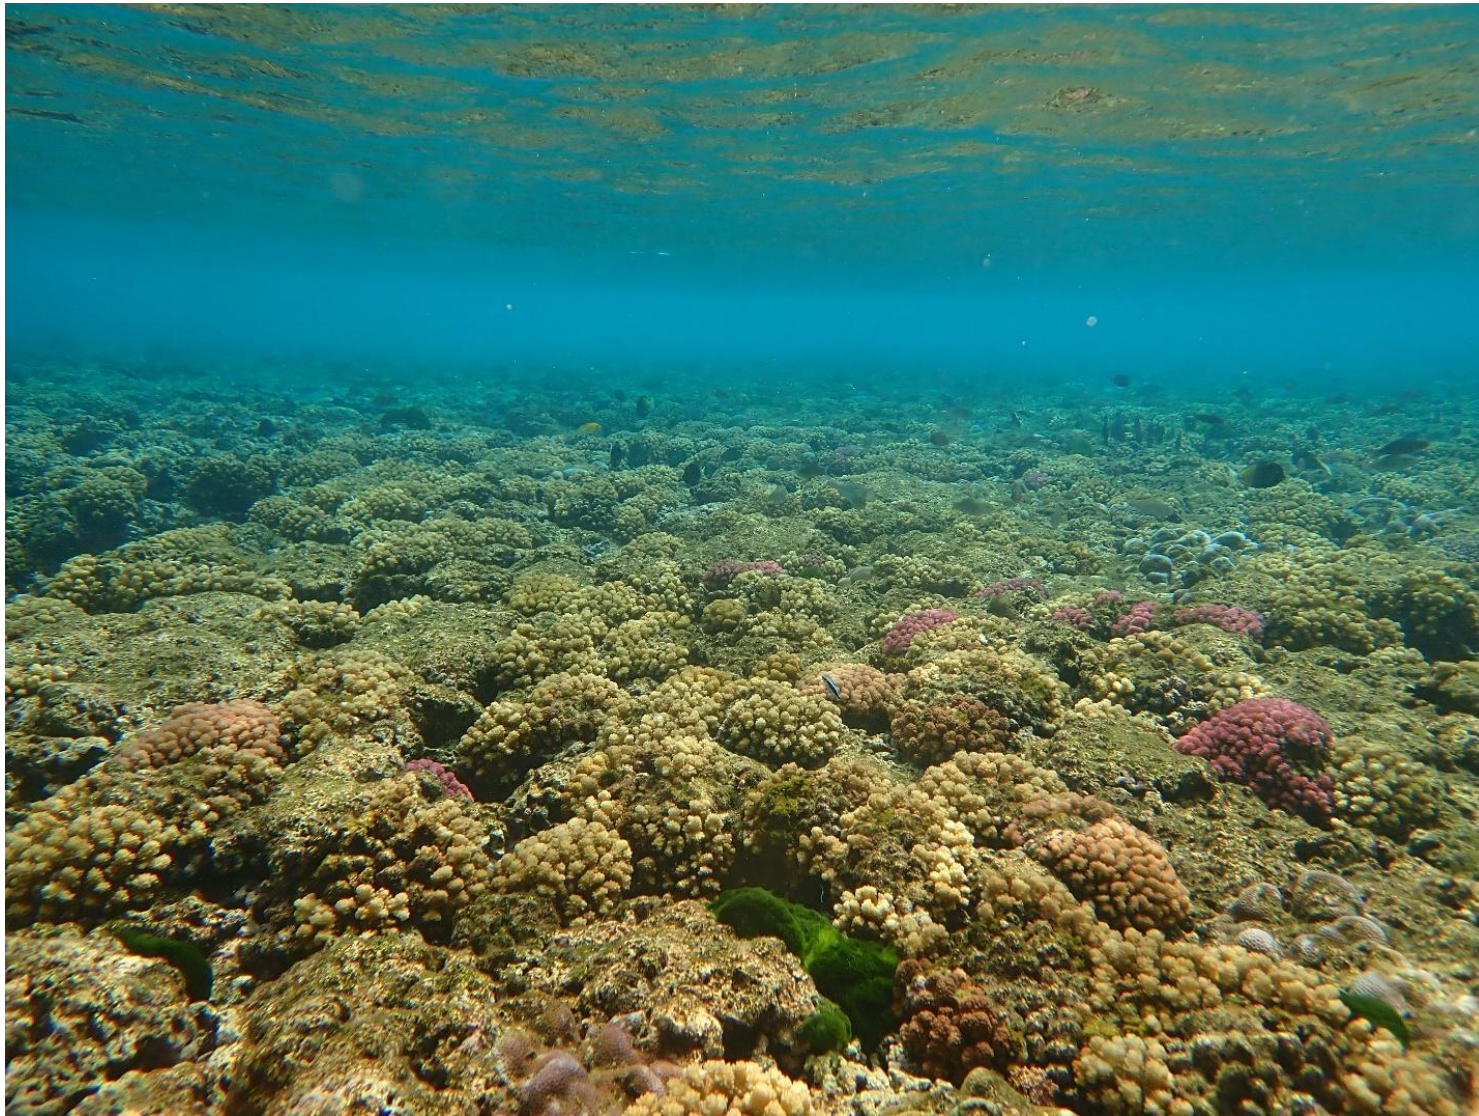
Figure 15: General photo of the reef crest habitat at Lasarino Beach, Tinian. Note that although this is not the specific area to be trenched for the conduit placement, much of the reef crest is comparable to this photo.

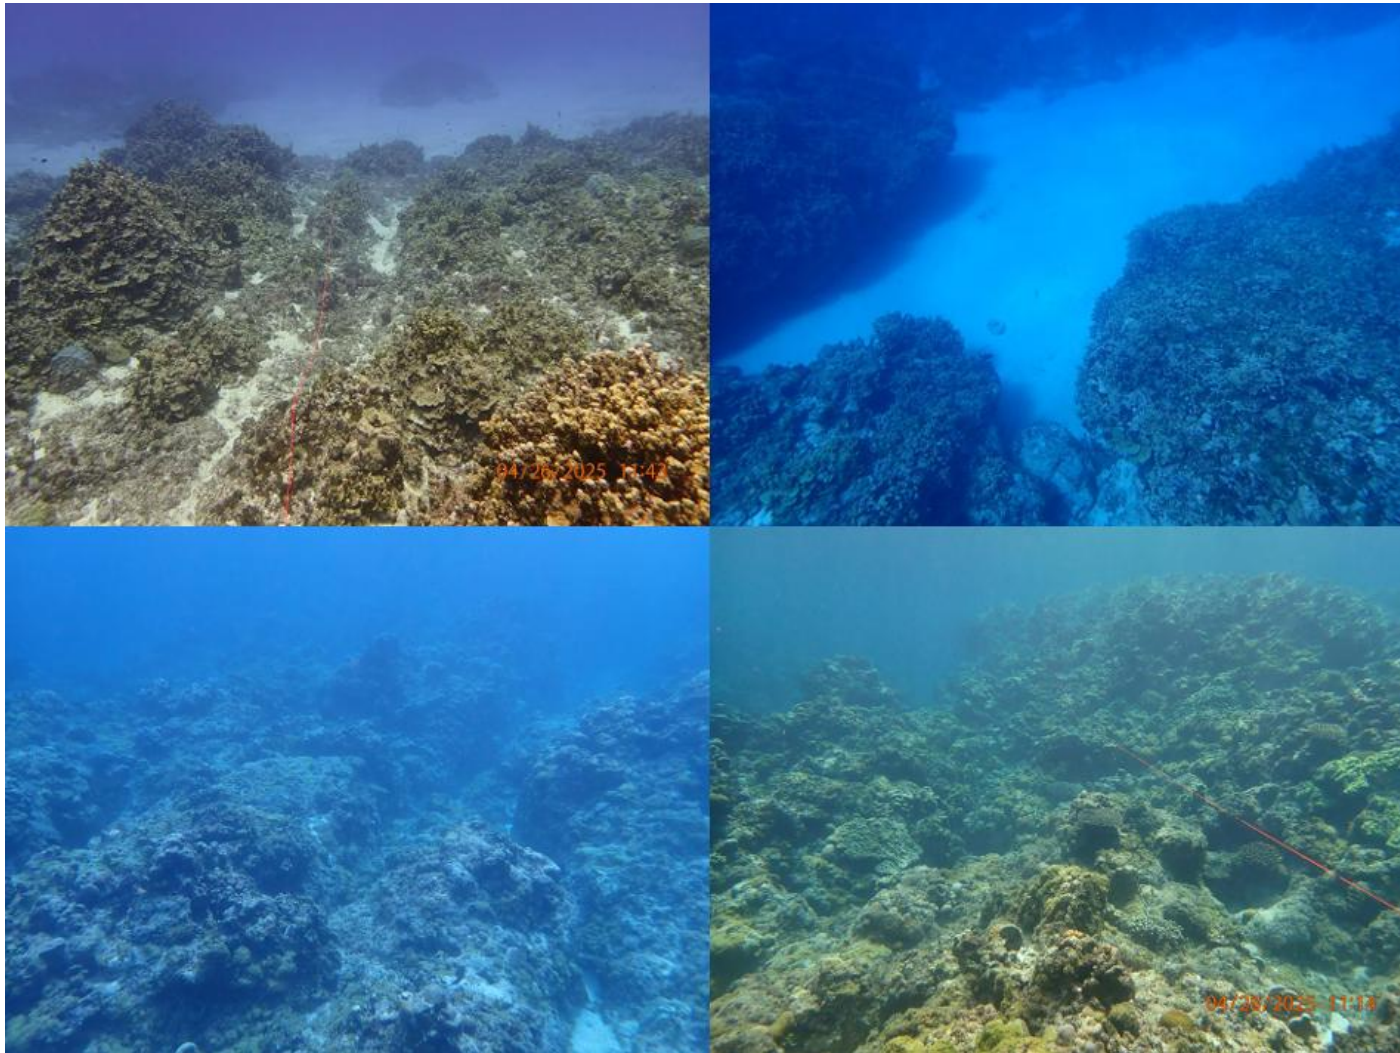
Figure 16: Top left, facing SW; cable landing entry route into the lower fore reef. Top right, facing South; sandy bottom channel that the cable landing will cross over. Bottom left, facing NE; cable route through the upper reef flat. Bottom right, facing NE; cable landing route through the upper fore reef

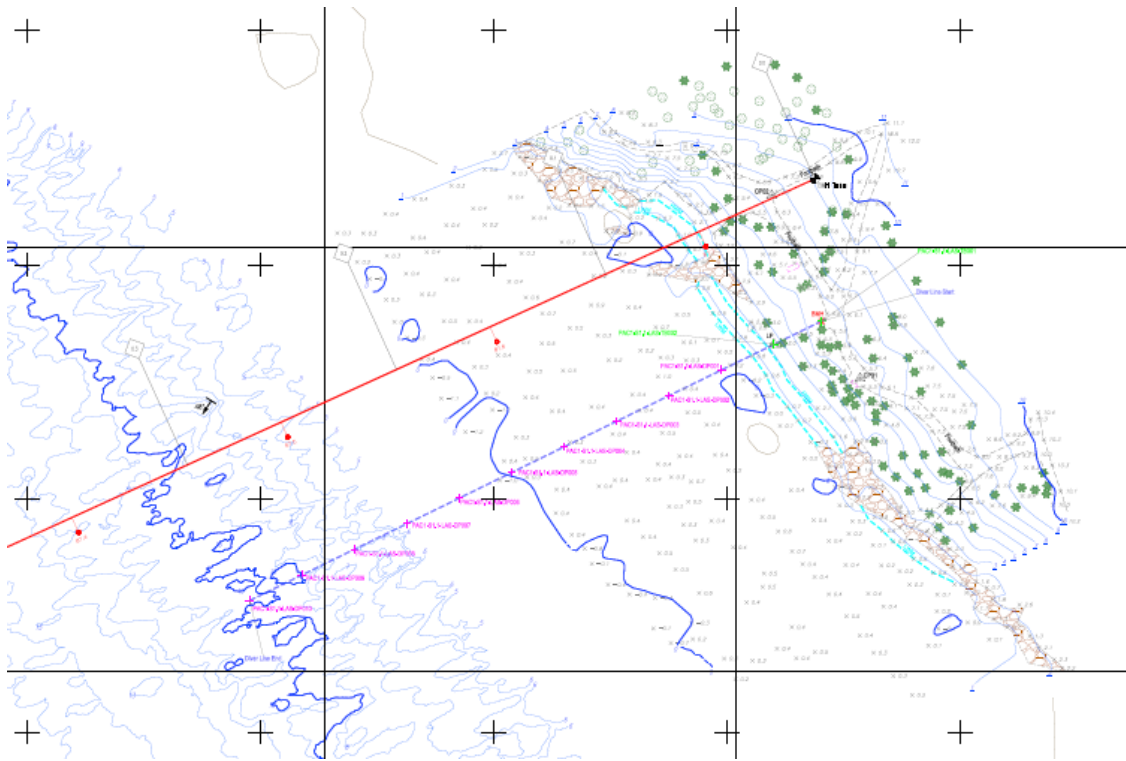
Image 2: Coral Survey for Original Route (March 2025)
(red dots = location of *A. globiceps*)

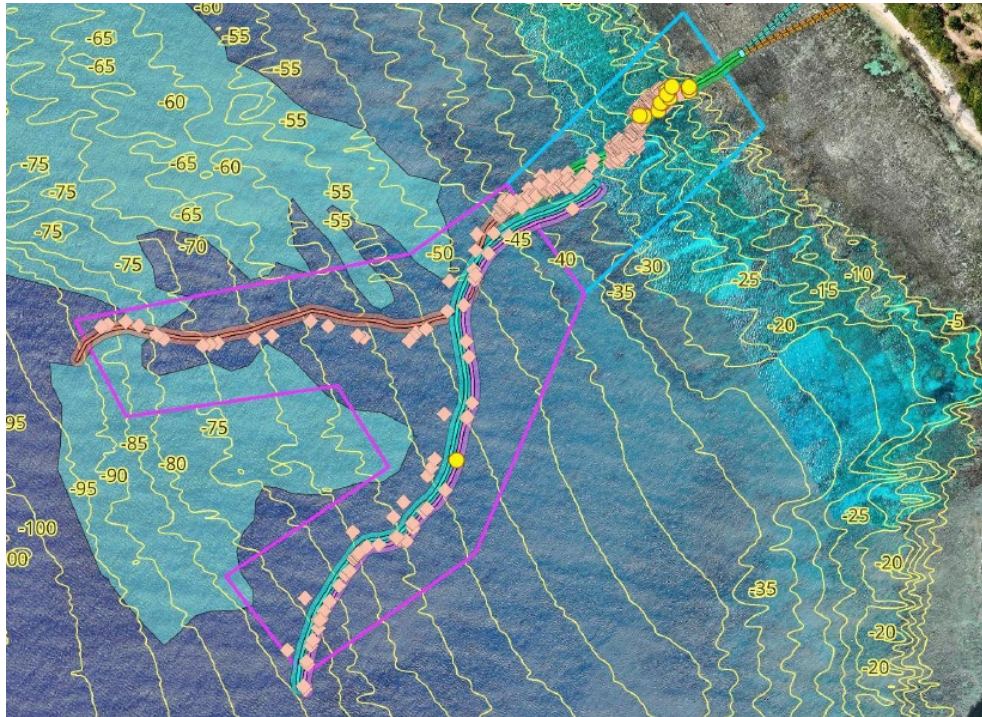
Image 4: Sea Floor Conditions approaching Fore Reef
